# INVESTIGATIONS ON Na<sub>2</sub>SO<sub>4</sub>- INDUCED LOW TEMPERATURE HOT CORROSION BEHAVIOR OF Mar-M 509 AT 750°C

**Key words:** Hot corrosion, Mar-M 509, Low temperature hot corrosion

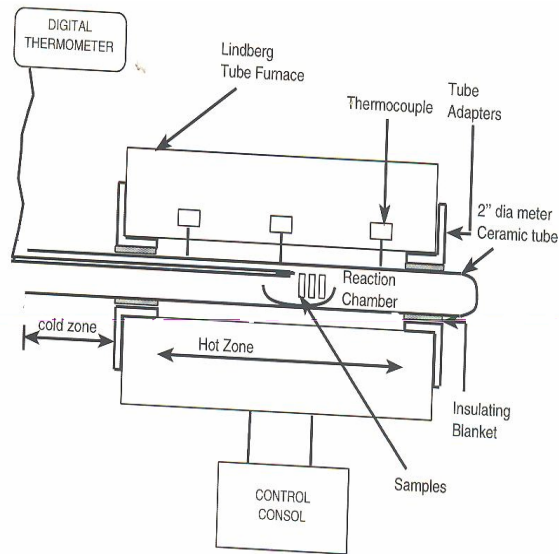
Fig.1 Experimental setup of high temperature Test system

and which can be operated to a maximum temperature of  $1200^\circ\text{C}$ . A one-end closed ceramic tube of 2 inch internal diameter is inserted into the tube furnace supported by tube adapters at both ends of the furnace. Two insulating blankets of alumina sponge were provided at the two-ends of furnace to minimize heat loss and /or temperature gradients within the furnace. The test temperature used in this study is  $750^\circ\text{C}$ . The test temperature in the reaction chamber is continuously checked with a chromel-aluminate thermocouple. In this test system, the samples are corroded for 1 hr and brought to cold zone to cool the specimens during the process of thermal cycling. Test runs were performed for the  $\text{Na}_2\text{SO}_4$  and  $\text{Na}_2\text{SO}_4+\text{CoSO}_4$  salt coating for 20 cycles to study the corrosion morphology during initial stages and 150 cycles to observe the corrosion morphology of corroded samples at the propagation stage. Salt coating method is adopted to coat the samples with salt mixtures after intensive polishing with Sic paper and diamond paste. The corrosion samples were examined using SEM and EDS.

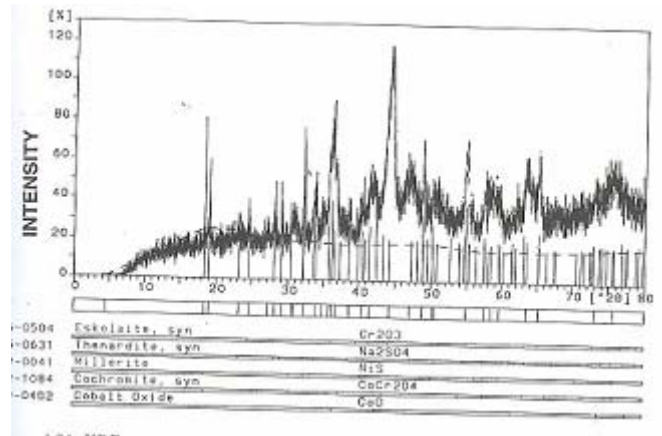
Fig3. XRD of pure  $\text{Na}_2\text{SO}_4$  coated Mar-M 509 for 20 cycles at  $750^\circ\text{C}$

Fig[2] shows the morphology of pure-  $\text{Na}_2\text{SO}_4$  coated Mar-M 509 after exposure for 20 cycles at  $750^\circ\text{C}$ . The scale formed on the alloy surface is primarily enriched in Cr indicating the presence of  $\text{Cr}_2\text{O}_3$  (spot D). At the alloy/oxide interface, Cr-depleted alloy islands were observed (spot A) A dark layer enclosing the metallic islands is rich in Co and Cr, indicating that it may consists of  $\text{Cr}_2\text{O}_3$  and CoO or  $\text{CoCr}_2\text{O}_4$ . It also appears from the EDS analysis at spot D that a few Ni-sulfide particles may be present in the dark layer. XRD results (Figure 3) confirms the presence of  $\text{Cr}_2\text{O}_3$ , CoO and NiS.

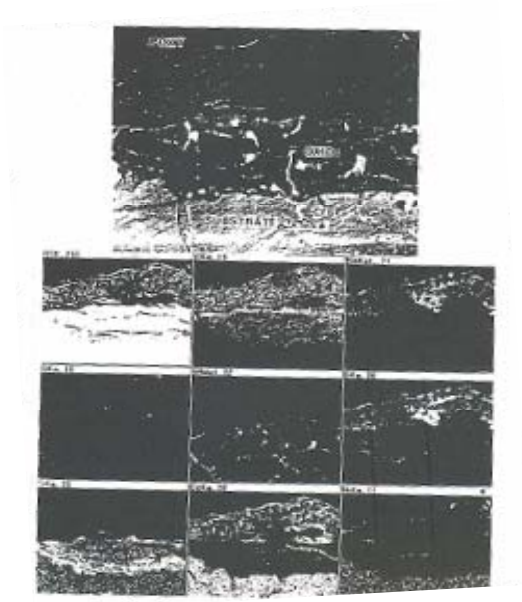
Fig 5. X-ray mapping of  $\text{Na}_2\text{SO}_4 + 52\%\text{CoSO}_4$  coated Mar-M509 after 150 cycles at  $750^\circ\text{C}$

From the above results, it can be inferred that the corrosion attack of  $\text{Na}_2\text{SO}_4+52\%\text{CoSO}_4$  forms deep pits resembling LTHC features where the pure- $\text{Na}_2\text{SO}_4$  coated samples shows the broad frontal attack with extensive internal sulfidation. The formation of pits is attributed to the formation of low melting eutectic of  $\text{Na}_2\text{SO}_4\text{-CoSO}_4$ , (visual examination revealed the presence of liquid at test temperature) further it penetrates and comes in contact with the alloy during thermal cycling. Sulfur ingresses through the liquid melt forms sulfides and further sulfidation-oxidation leads to the formation of these pits.
